NRL Report 6293
AFML-TR-64-408

Electron Microscope Fracture Examination to Characterize and Identify Modes of Fracture

C. D. BEACHEM

September 28, 1965

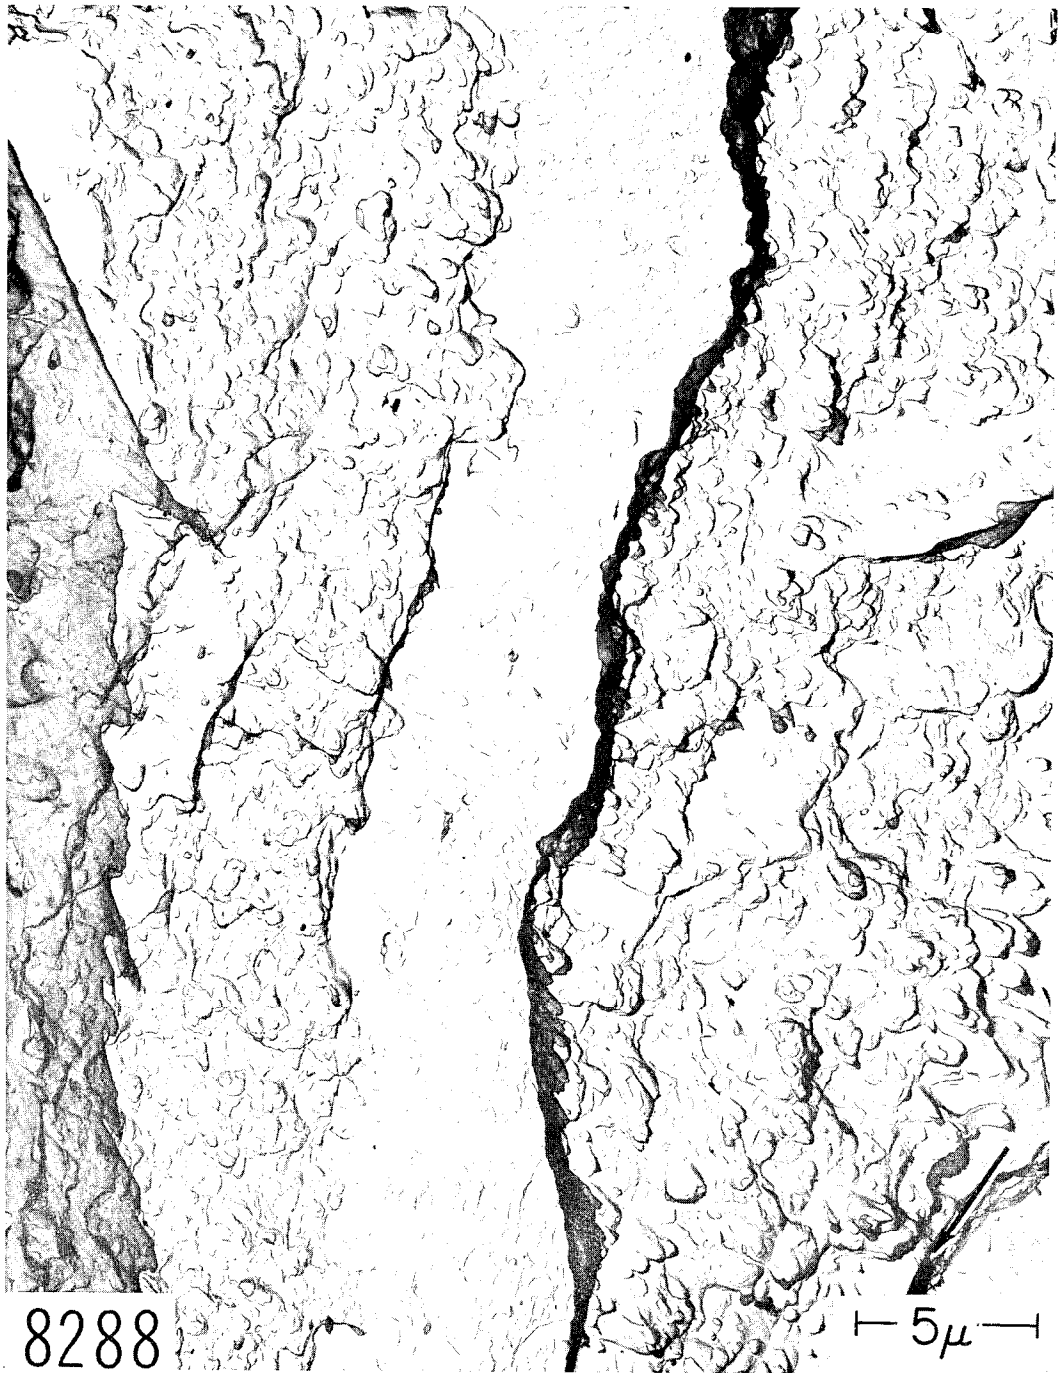
Fig. 2 - Room temperature impact square fracture plane-strain dimpled rupture in 2020 T651 aluminum alloy. Cellulose acetate-carbon replication technique. Palladium shadowed. 6000X.

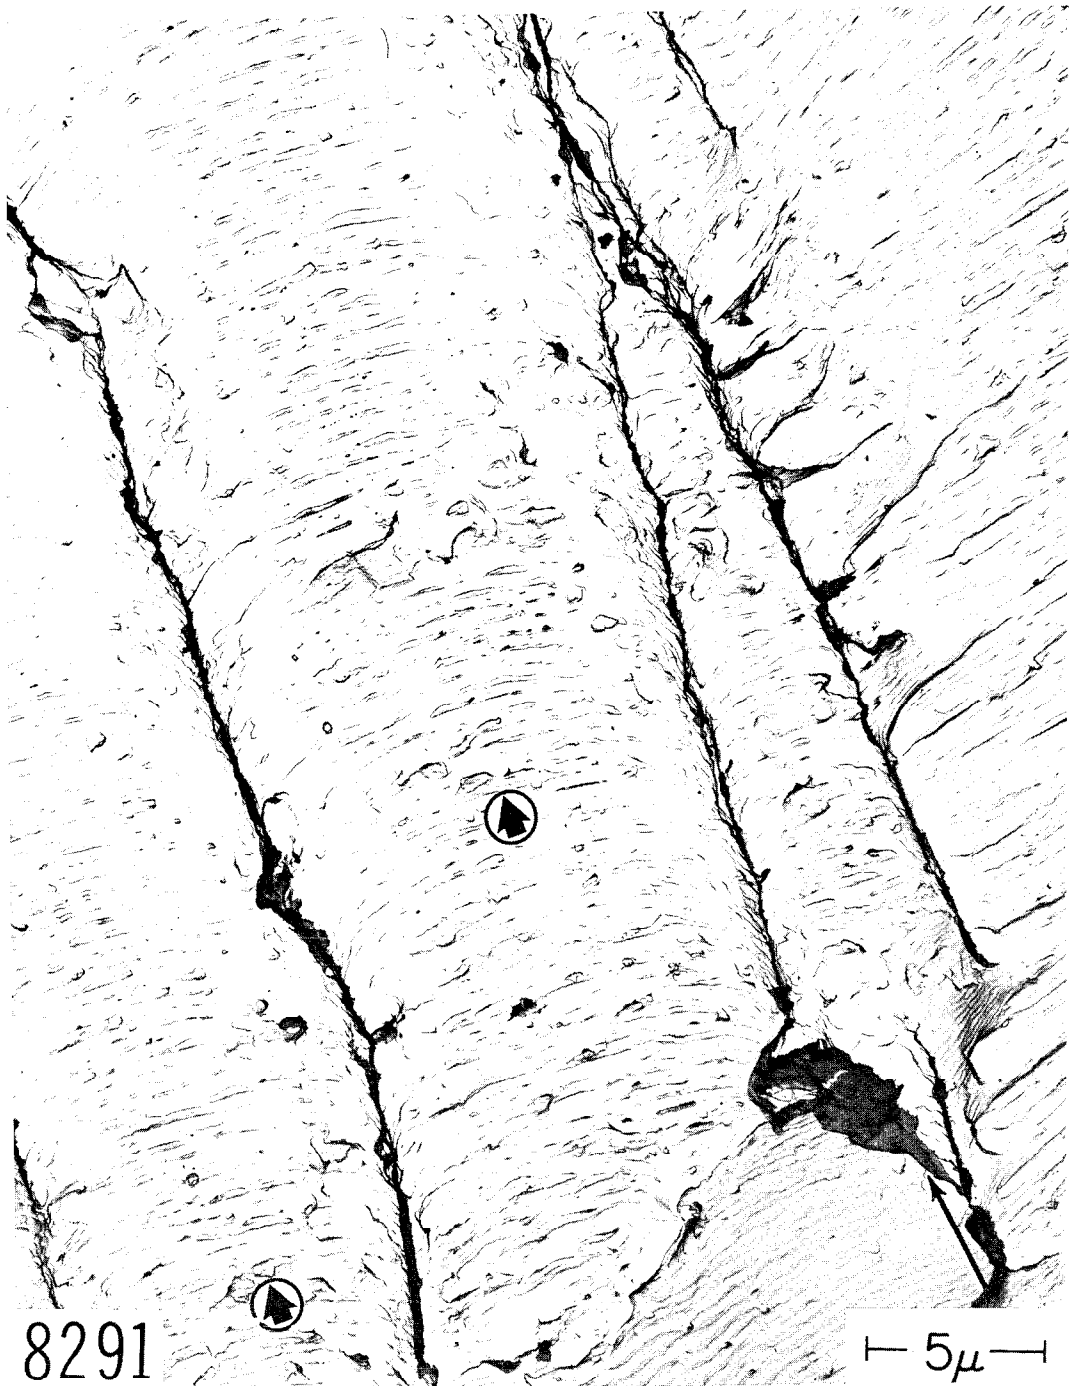
Fig. 6 - Tension-tension plane-strain fatigue markings in an RW fatigue crack in 2020 T651 aluminum alloy. Arrows indicate tongue-shaped cracks along parts of some of the striations. Cellulose acetate-carbon replication technique. Palladium shadowed. 6000X.

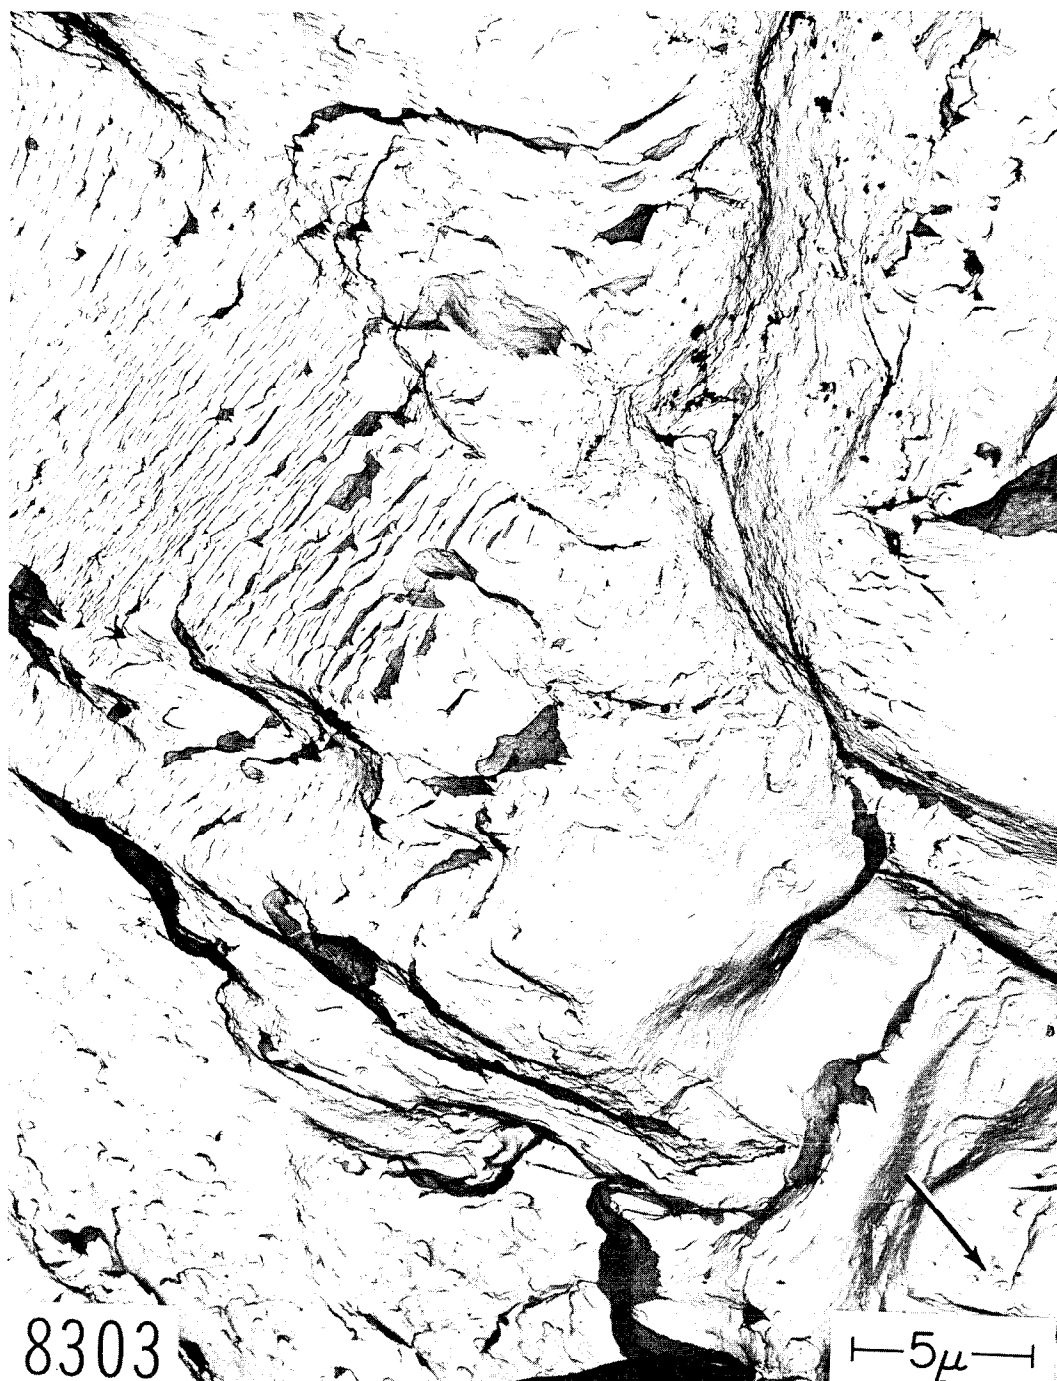
Fig. 8 - Tension-tension plane-strain fatigue markings in the WR fracture direction in 2020 T651 aluminum alloy. Cellulose acetate-carbon replication technique. Palladium shadowed. 6000X.

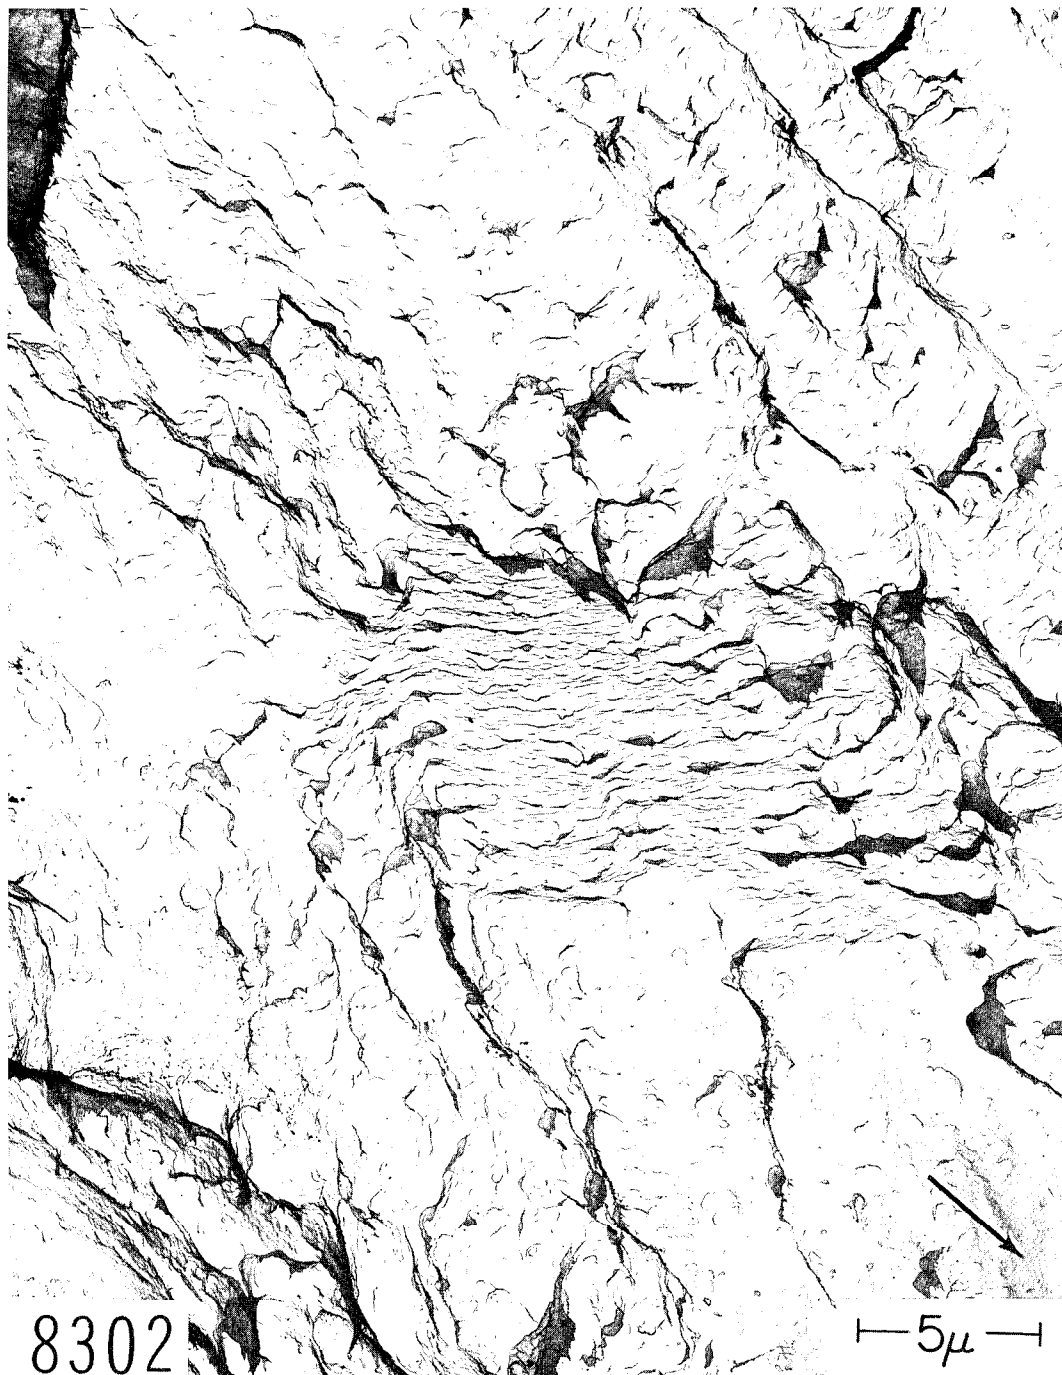
Fig. 9 - Tension-tension plane-strain fatigue markings in the WR fracture direction in 2020 T651 aluminum alloy. Cellulose acetate-carbon replication technique. Palladium shadowed. 6000X.

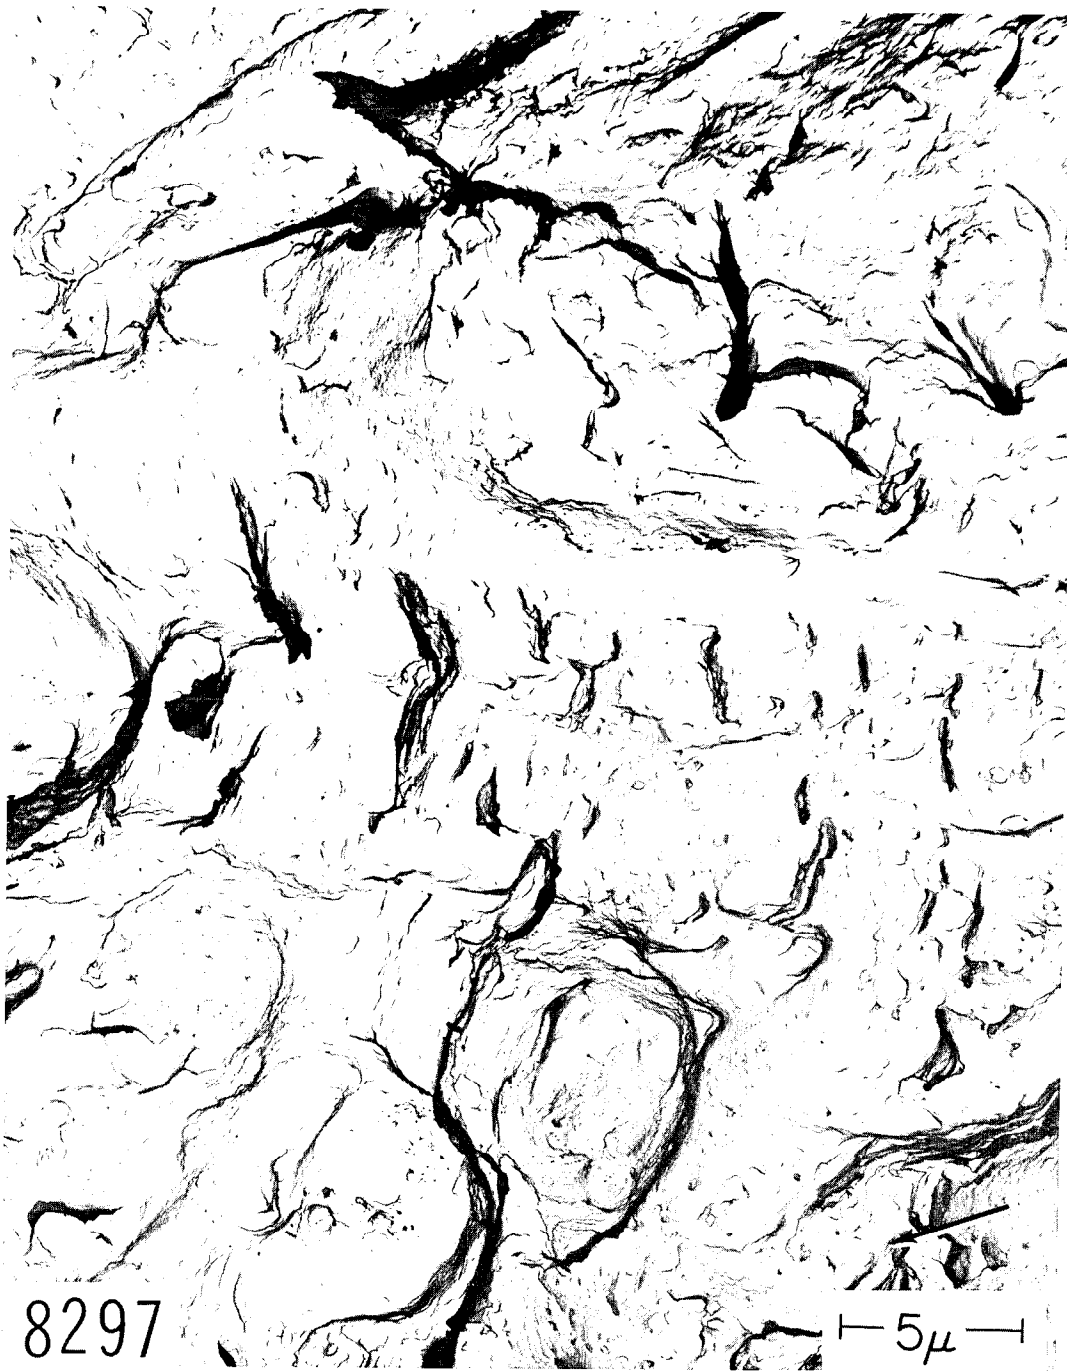
Fig. 11 - Tension-tension plane-strain fatigue markings in the WR fracture direction in 2020 T651 aluminum alloy. Cellulose acetate-carbon replication technique. Palladium shadowed. 6000X.

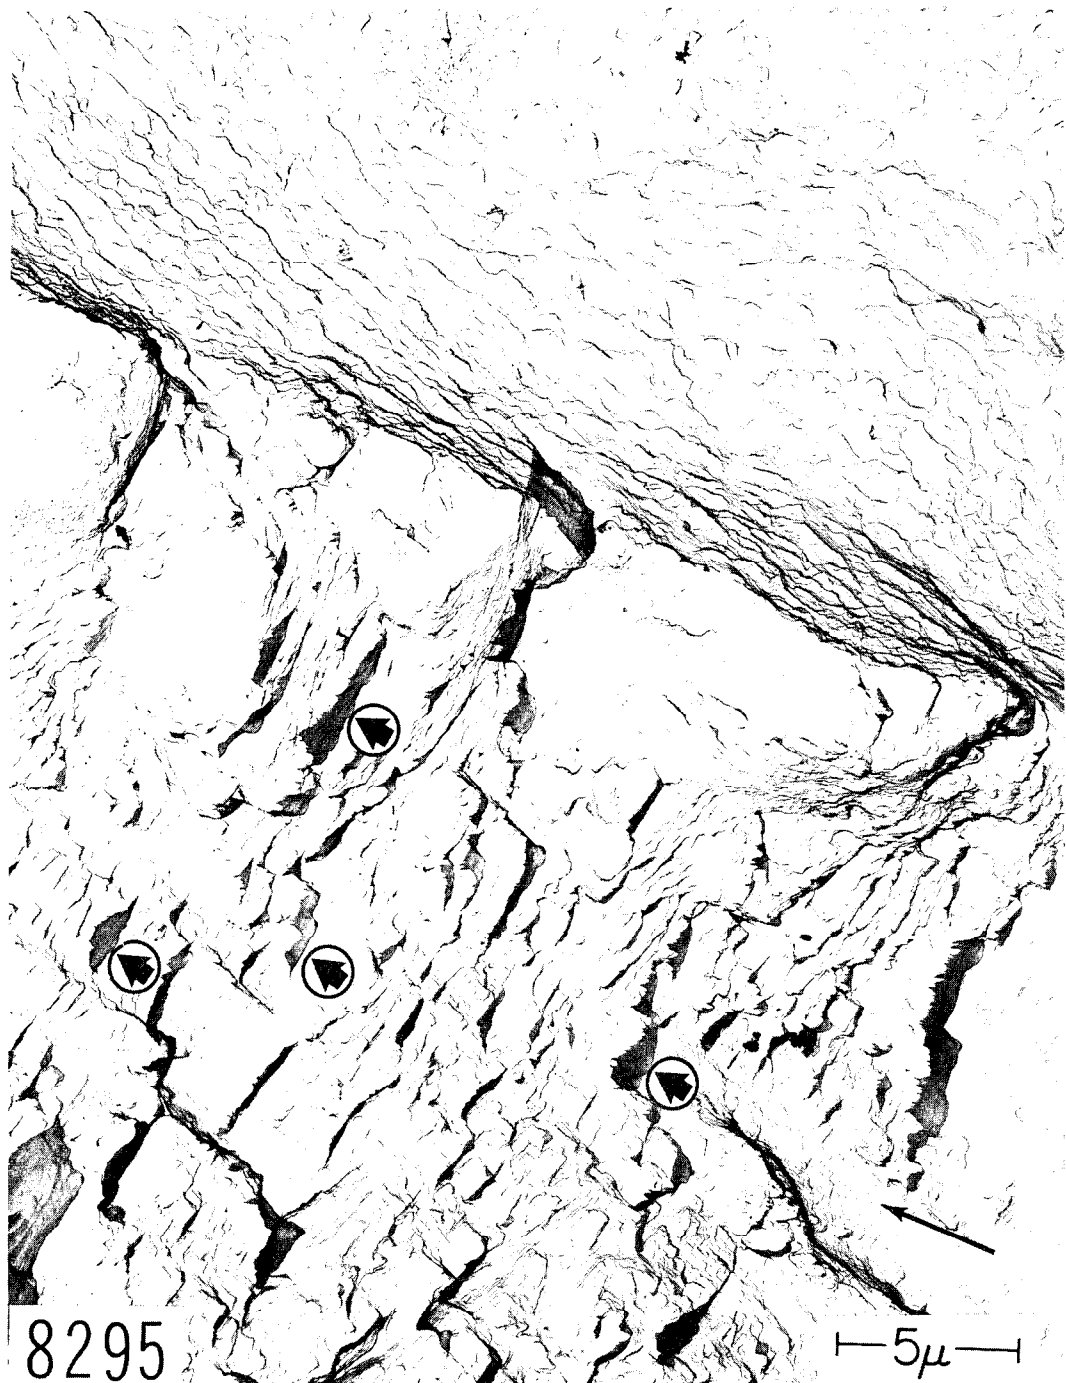
Fig. 12 - Tension-tension plane-strain fatigue markings in the WR fracture direction in 2020 T651 aluminum alloy. Short deep cracks are indicated by arrows. Cellulose acetate-carbon replication technique. Palladium shadowed. 6000X.

plate specimens. The specimens were 3/4 in. thick, 2 in. wide, and 5 in. long. The fatigue cracks were propagated under tension-tension loading (2000 pounds to 5000 pounds) at 3600 cycles per minute. The specimens were broken after precracking by impact loading. One specimen was tested in the TW direction.* The impact energies for both specimens were about 15 foot pounds. Plane strain fracture surfaces are shown in Figs. 1-3. Though these were taken from the RW specimen, they are characteristic of the fracture surface features of the plane strain surfaces in both specimens. Figure 1 shows typical dimples and some scraping artifacts (2). Figure 2 shows what is probably the effect of a banded structure. Figure 3 shows some of the flat regions (arrows) that were often associated with dimples. The fatigue markings for the RW direction are shown in Figs. 4-6. Figures 4 and 5 show that the fatigue markings often were mixed with tear dimples. Figures 5 and 6 show that striations often had tongue-shaped cracks (arrows) along parts of their lengths. Figures 7-12 show the fatigue markings found on the WR fracture surface. In Figs. 7 and 8, the fatigue markings are largely of the usual type (expected in aluminum alloys). However, Figs. 9-12 show, in increasing order, some markings that are not nicely shaped, smoothly curved groups of striations, but consist of short deep cracks as evidenced by thin films of carbon standing in relief on the replica surface (arrows in Fig. 12). Figure 12 also shows a patch of dimples in the upper portion.

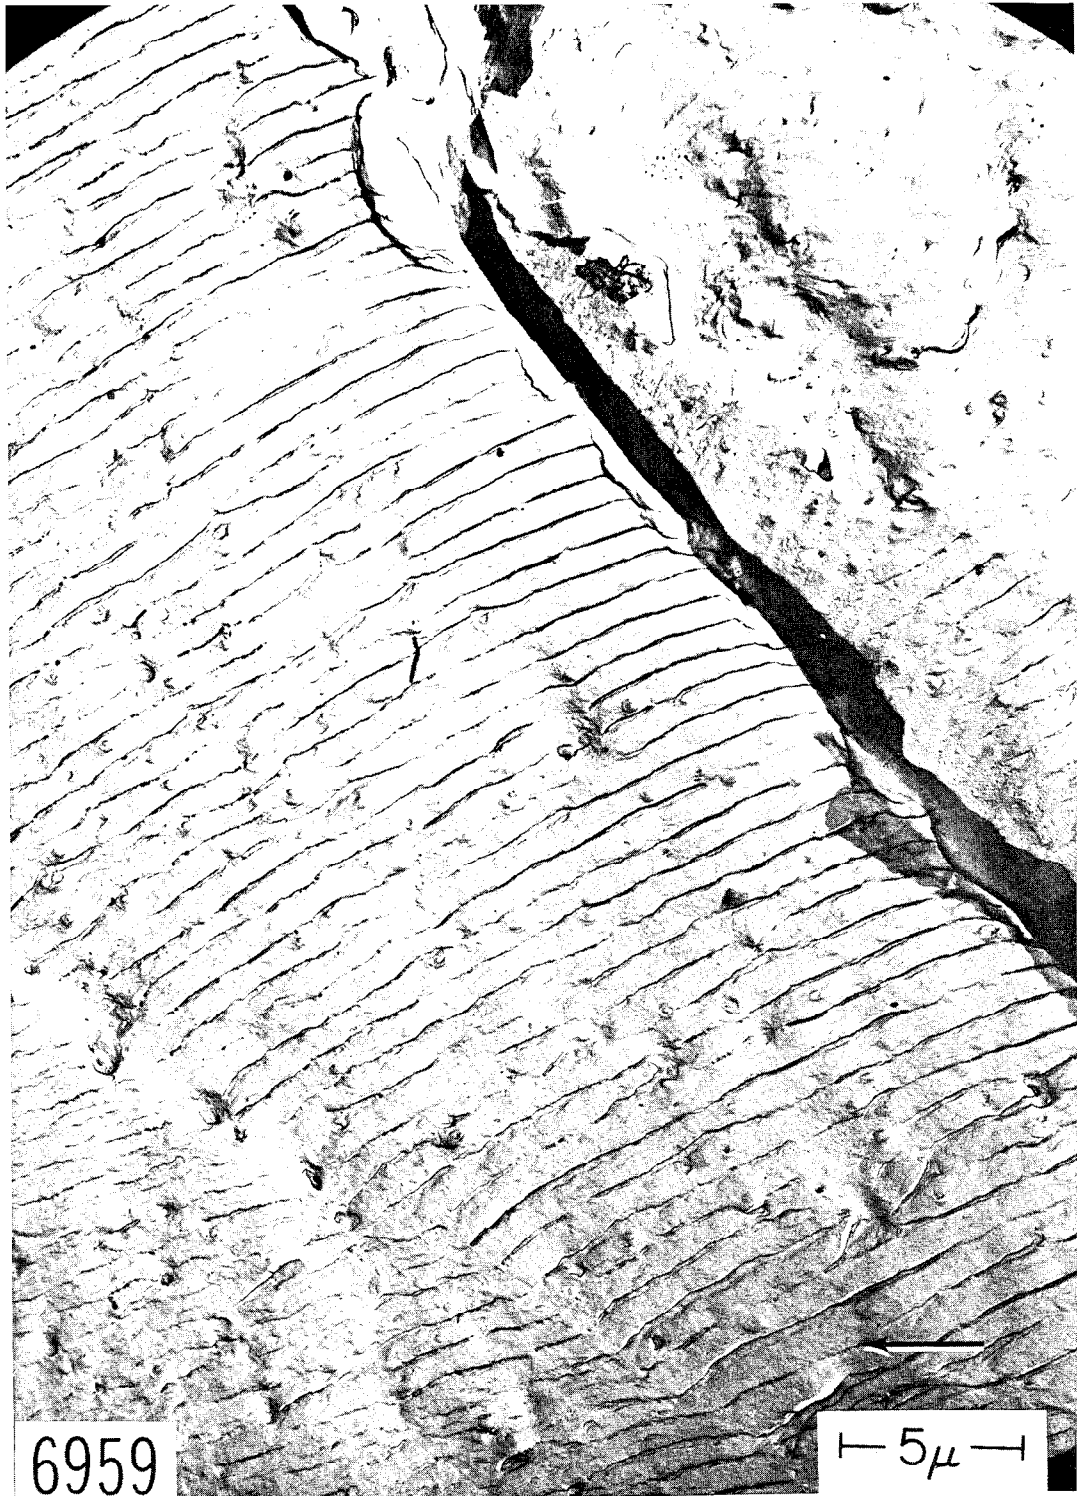
Fig. 13 - Tension-tension plane-strain RW fatigue markings in 2024 T851 aluminum alloy plate. Cellulose acetate-carbon replication technique. Palladium shadowed. 6000X.

Specimens from three orientations (RW, WR, TR) were cut from a 5-in. thick plate of 2024 T851. The specimens were prepared and tested in the Mechanics Division and were of the short Single Edge Notched (SEN) type - 1/4 in. \times 1-1/2 in. \times 3.3 in. The fracture toughness values were 46.2 KSI $\sqrt{\text{in.}}$ for the RW direction, 37.5 KSI $\sqrt{\text{in.}}$ for the WR direction, and 23.2 KSI $\sqrt{\text{in.}}$ for the TR direction. The fatigue precracks were made in bending on a lathe and no records of the stresses were made. Figures 13-24 show the influence of orientation on the appearance of the fatigue markings. Figures 13-16 show the RW markings to be, in general, evenly spaced, gently curved striations arranged in groups that are separated by steps (black near-vertical lines in Fig. 15).

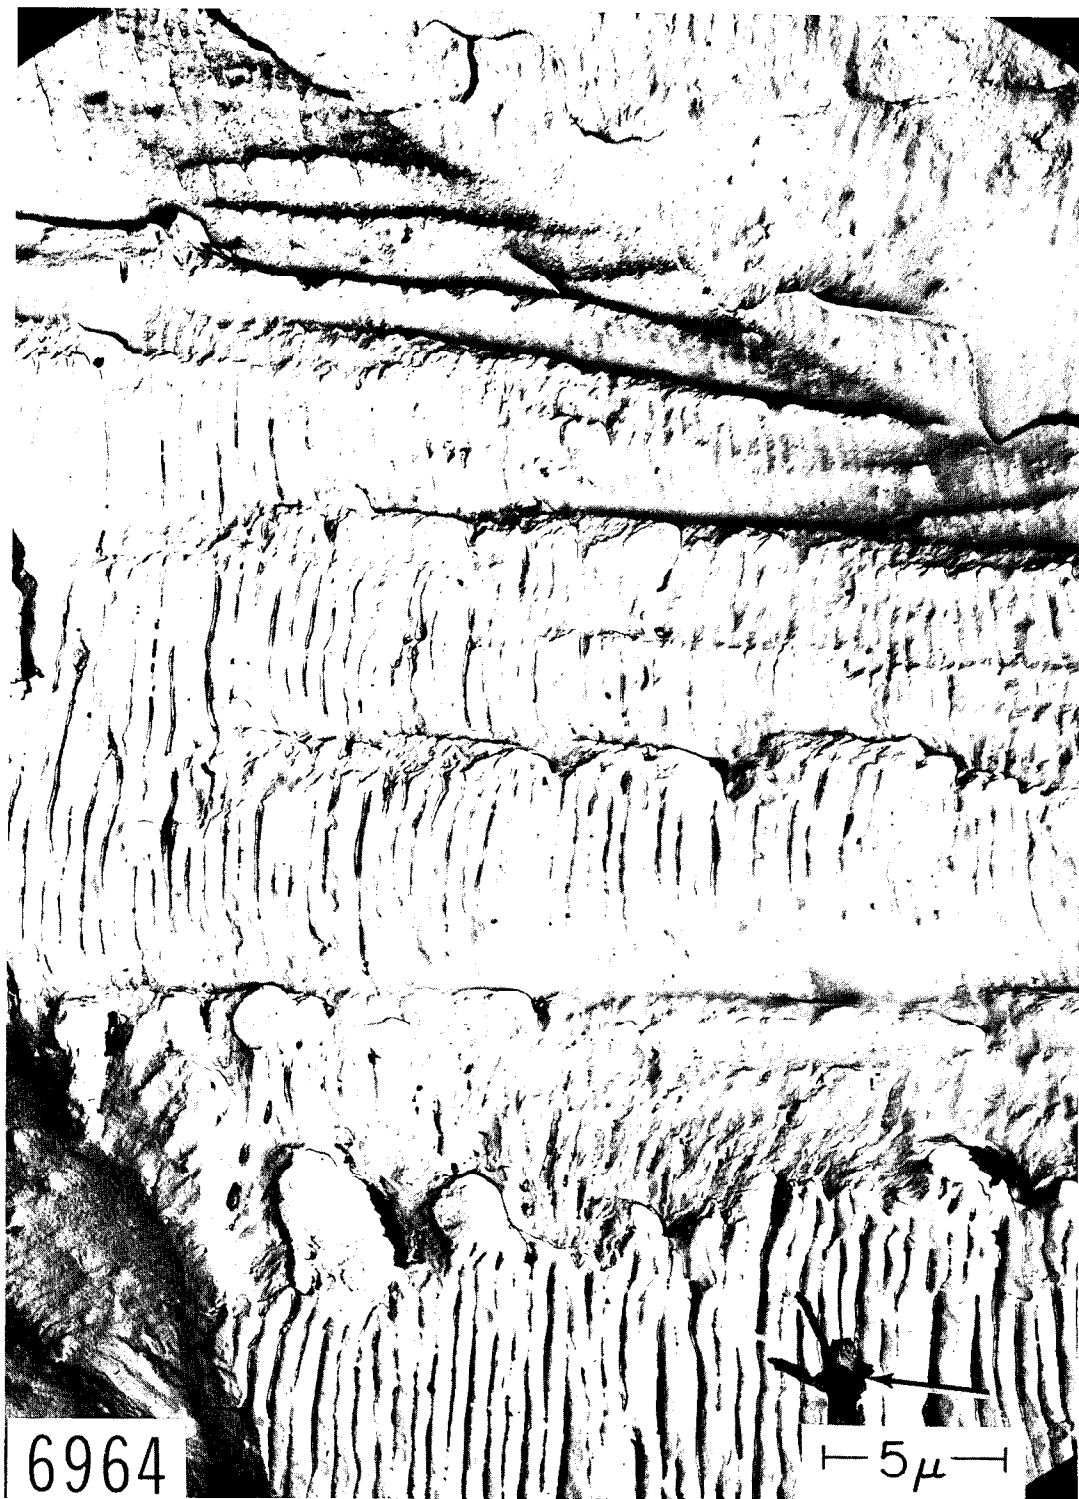
Fig. 14 - Tension-tension plane-strain RW fatigue markings in 2024 T851 aluminum alloy plate. Cellulose acetate-carbon replication technique. Palladium shadowed. 6000X.

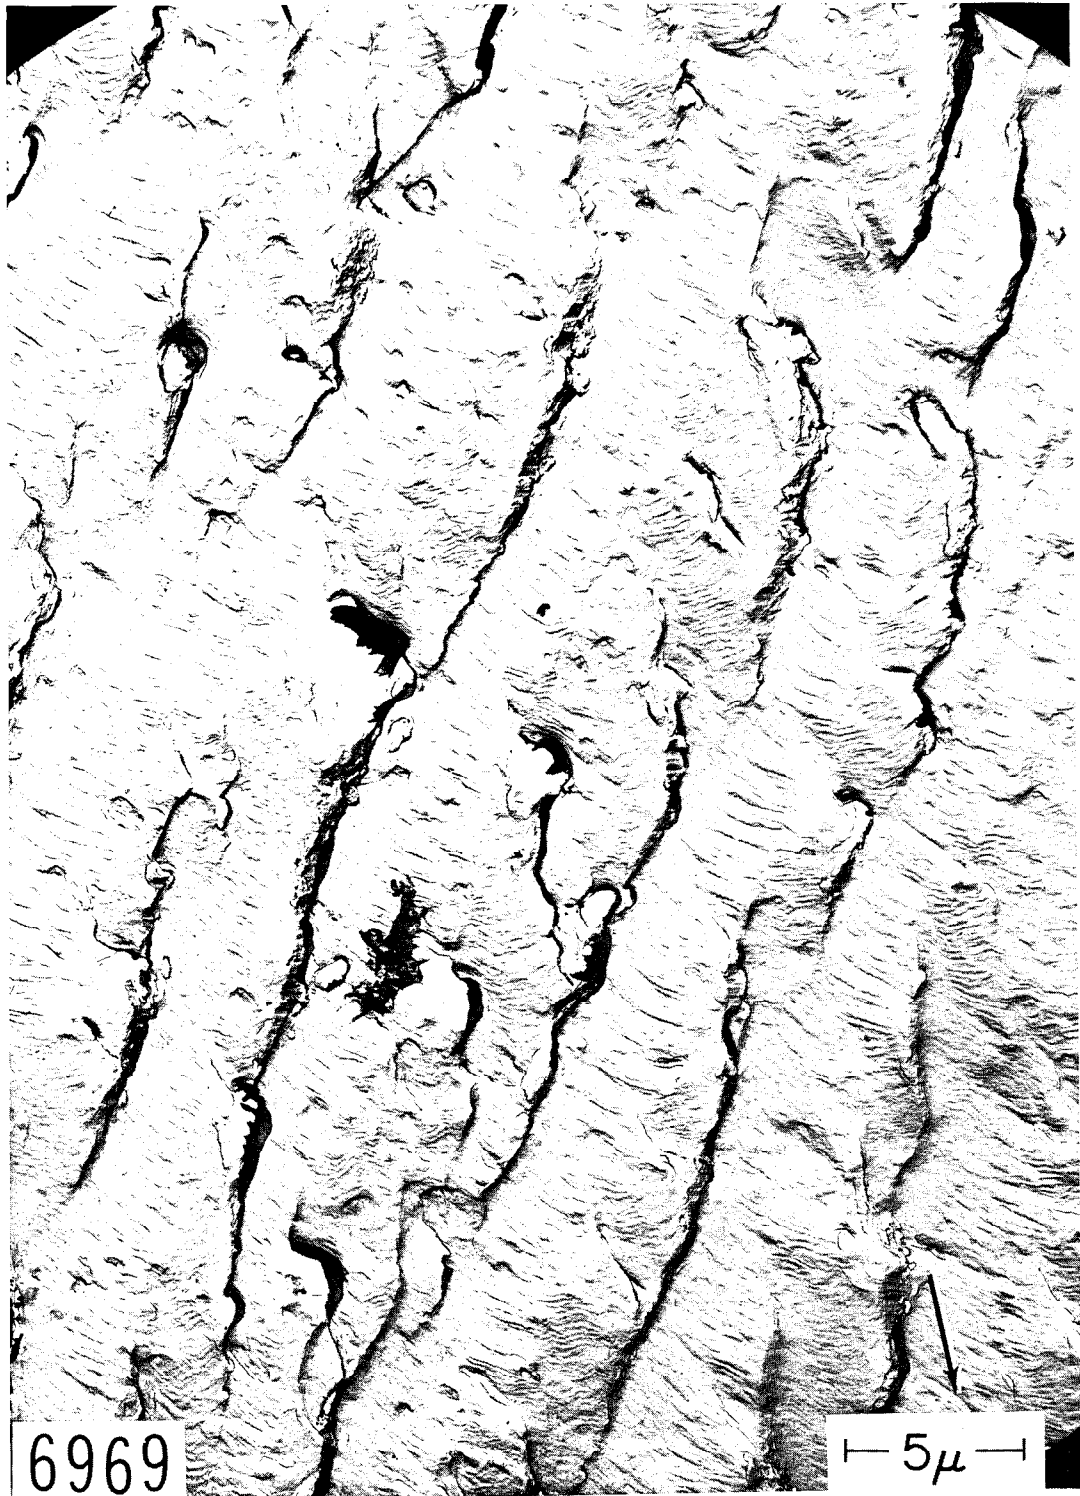
Fig. 15 - Tension-tension plane-strain RW fatigue markings in 2024 T851 aluminum alloy plate. Cellulose acetate-carbon replication technique. Palladium shadowed. 6000X.

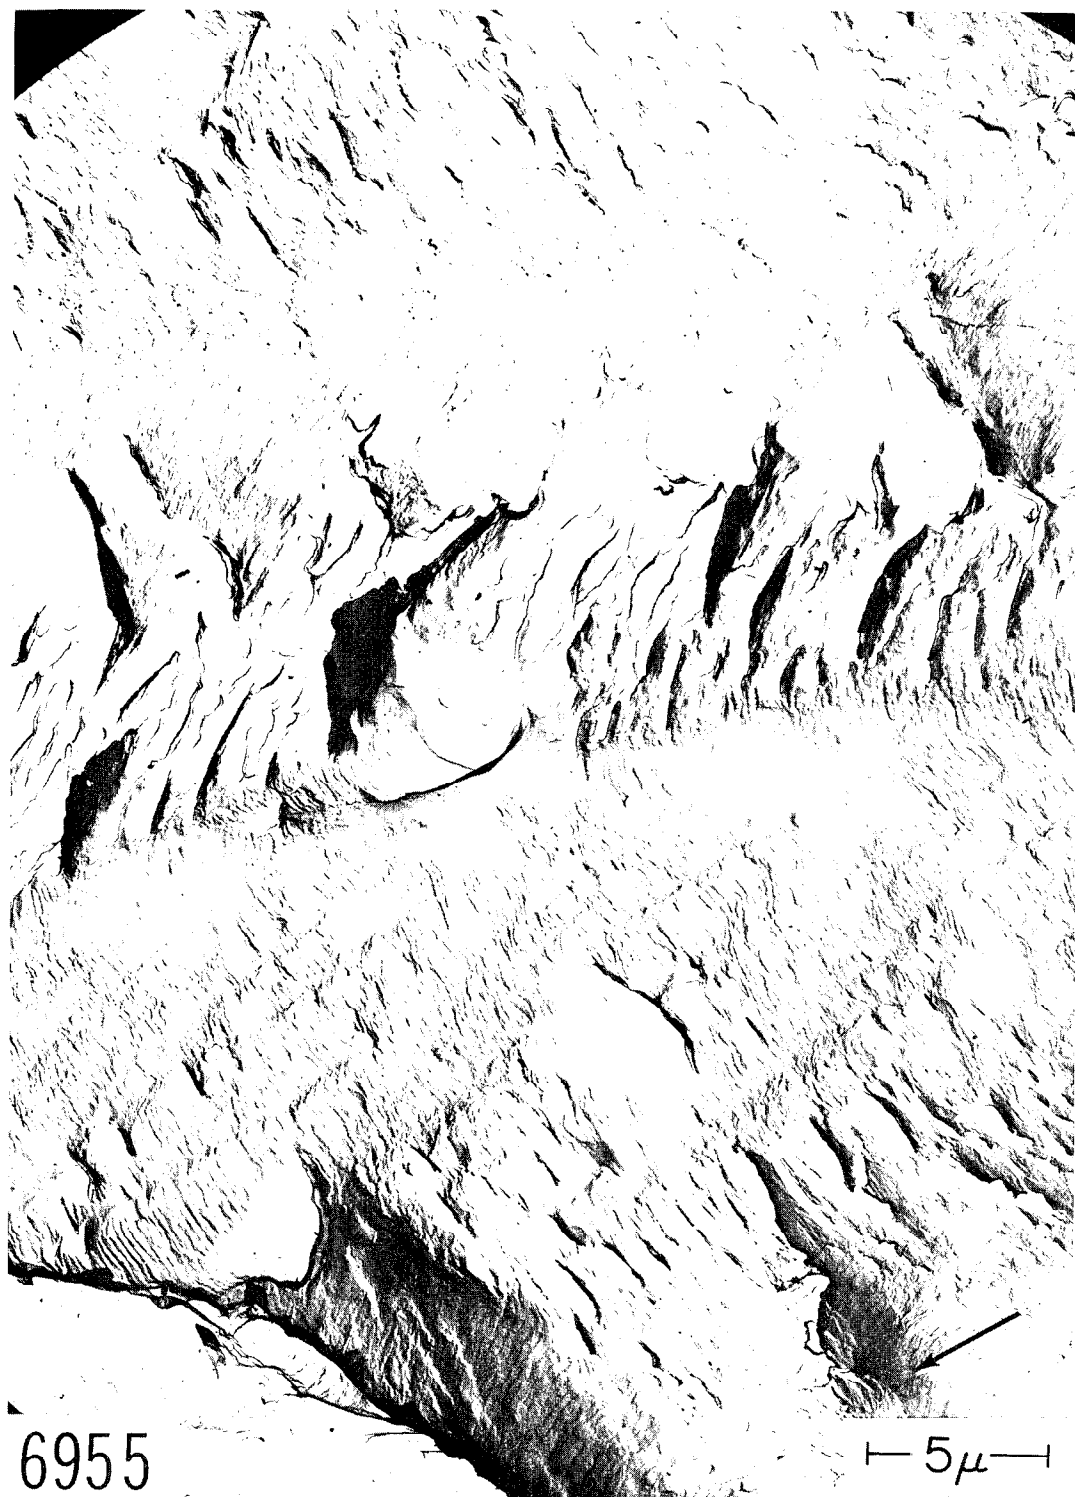
Fig. 16 - Tension-tension plane-strain RW fatigue markings in 2024 T851 aluminum alloy plate. Cellulose acetate-carbon replication technique. Palladium shadowed. 6000X.

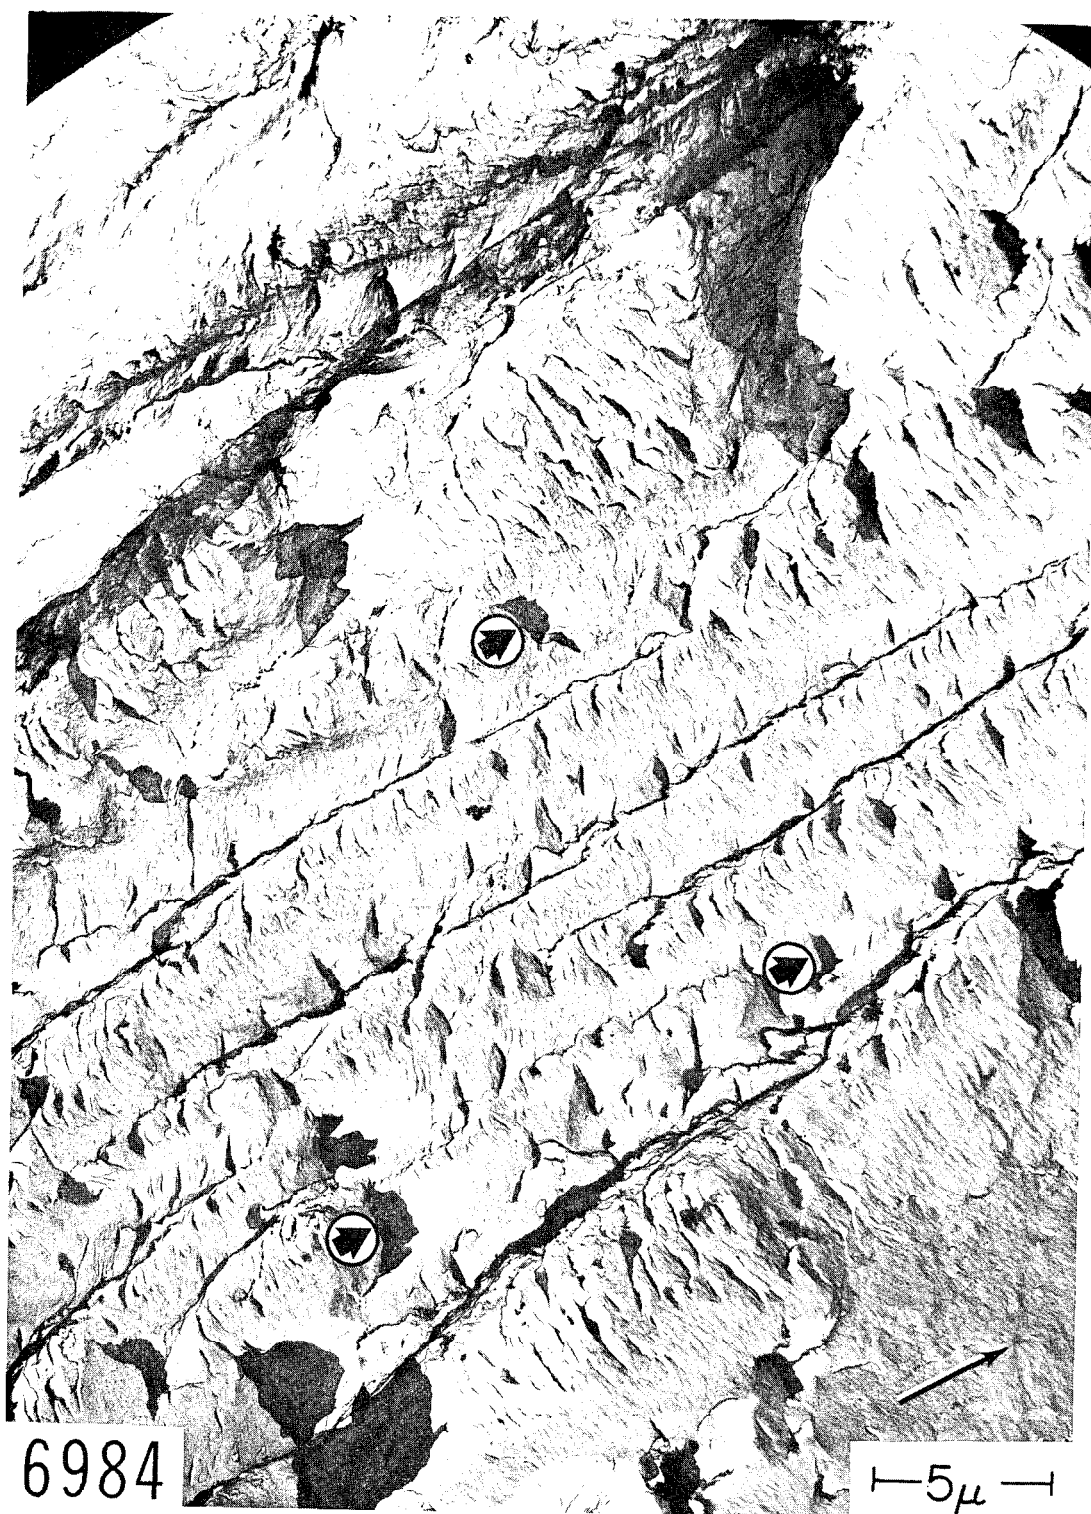
Fig. 17 - Tension-tension plane-strain WR fatigue markings in 2024 T851 aluminum alloy plate. Cellulose acetate-carbon replication technique. Palladium shadowed. 6000X.

Figures 17-20 show typical fatigue surface features in the WR direction. The first three fractographs show short, deep cracks (arrows in Fig. 17) while the fourth (Fig. 20) shows a rather smooth surface. Figure 18 shows a "river pattern" of steps with the same sense of convergence that is found in cleavage (i.e., the fracture propagates down-river). It is also apparent in Fig. 18 that individual segments of the local fatigue crack propagated on different planes. The near horizontal dark bands across the top (between the large arrows) are examples of fatigue on a set of planes whose orientation as a group is different from that of the region as a whole. This strongly suggests a crystallographic influence on the fatigue mechanisms, with the fatigue crack segments possibly seeking to propagate along certain crystallographic planes. A number of these segments (small arrows) are seen to be replicated partially as secondary cracks and partially as portions of the major fracture surface.

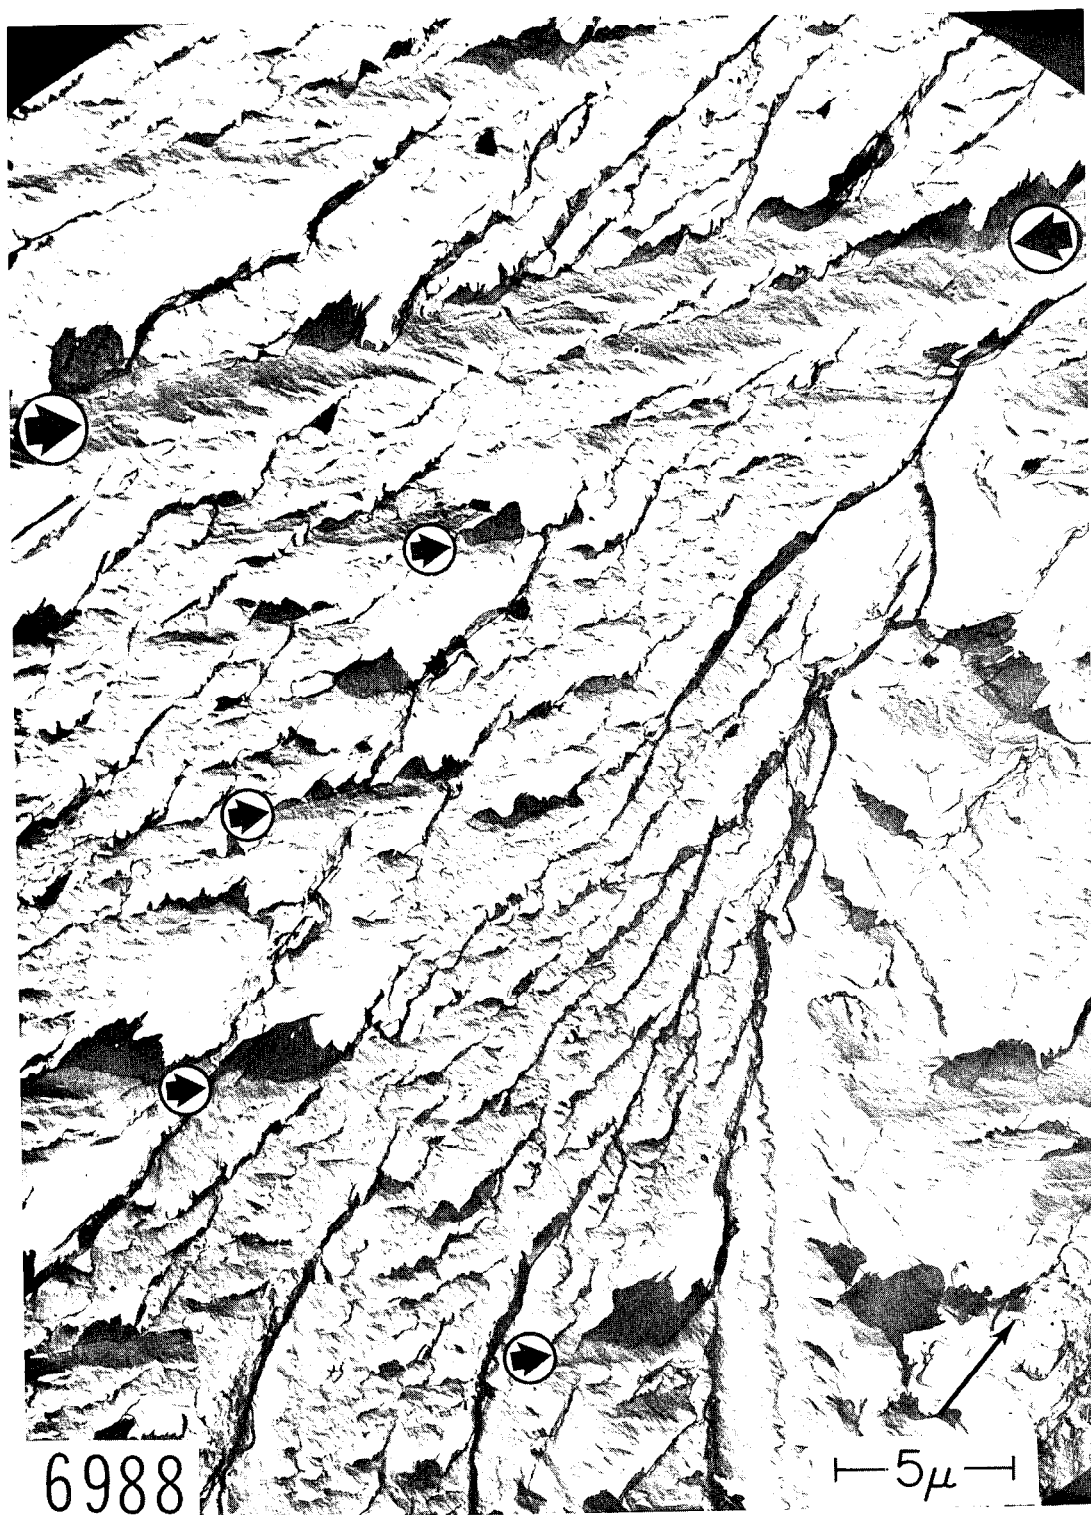
Fig. 18 - Tension-tension plane-strain WR fatigue markings in 2024 T851 aluminum alloy plate. Cellulose acetate-carbon replication technique. Palladium shadowed. 6000X.
